SI B18 01 18
Exhaust Systems

March 2018
Technical Service

DIAGNOSING NOISE FROM THE REAR EXHAUST FLAP (B58)

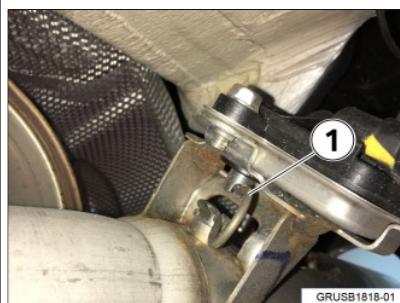
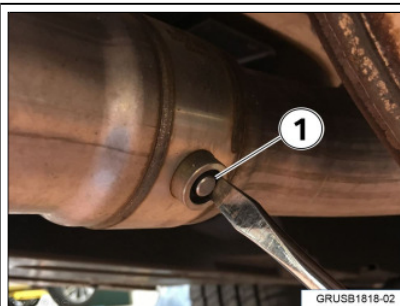
1. DME software application error (I-level is lower than F020-17-11-540) may cause the flap to stay in an undefined position which will cause it to rattle.
2. Loose or failed fixing bow (clip that connects the exhaust flap actuator to the exhaust flap)
3. Excessive play in the pivot bushing of the exhaust flap.

| | <ol style="list-style-type: none"> 2. If the fixing bow (1) is loose or damaged or missing – Replace the fixing bow. |
